INSPECTION AND CONDITION ASSESSMENT REPORT ON A LEAKING ROOF ON A SINGLE STOREY STRUCTURE BELONGING TO AFRICAN ANGEL

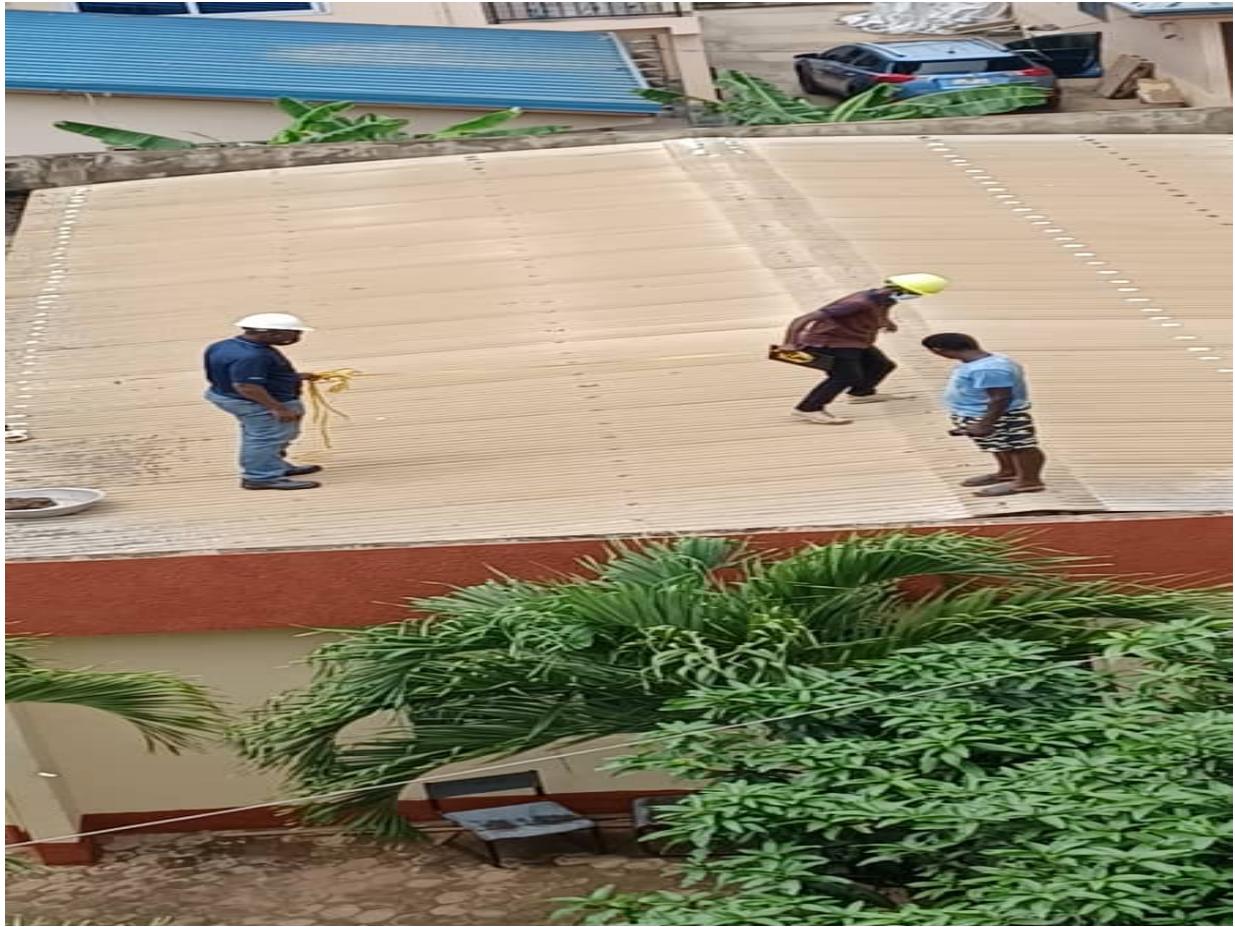
1. There were evident that some repair works had been undertaken on the long span aluminium roofing sheet. The extent of the repair was a clear indication of an exercise that was to arrest leakage from the sheets.

1. The pitch of the existing roofing sheet installations was shallow and that can potentially cause ingress of rain water if there is any minor defect in the integrity of the sheets. However, with a video of the leaking roof made available to the team at the time of the inspection, it was obvious that the extent of the leakage was not through the roofing sheets.

Pict. #1: Inspection of the Roofing Sheet

1. Carefully removing the aged and deteriorated long span aluminium roofing sheet from the building

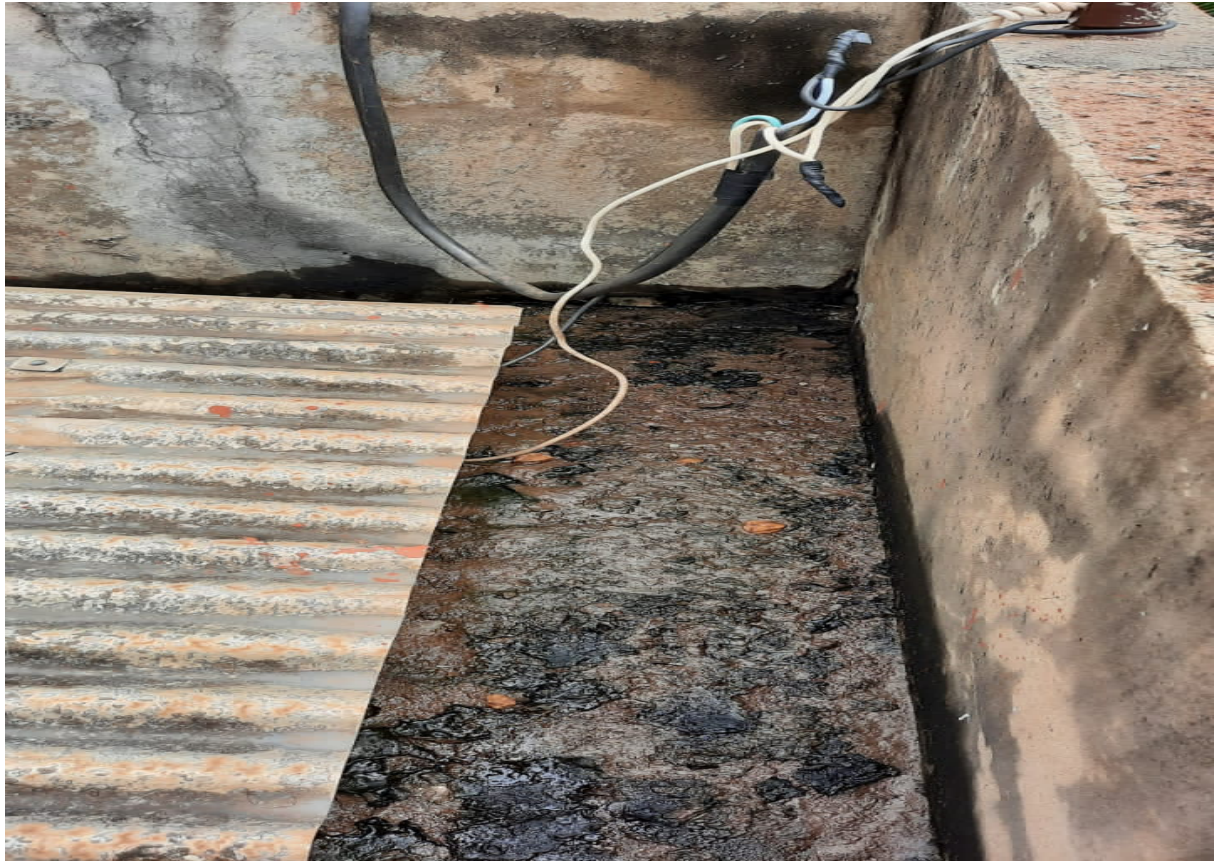
2. The drainage channel along the peripheral of the roof was choked with sand. The situation had resulted in the accumulation of pockets of water which was contributing extensively to algae growth. Pic. #3 shows the extent of siltation within the channel

2. The location of the building, abet, the untarred sandy road was contributing to the deposition of the sand and silt within the roof drainage channel. Unfortunately, the lack of a routine cleaning maintenance of the roof has exacerbated the degree of deposition of the sand. The effect is the impediment of free flow of rainfall into the roof drainage pipes. The resultant consequence is the quick accumulation of water within the channels, overtopping the upstand and subsequently flowing into the building.

Pict. #3: Silt Deposit within Roof Drainage Channel (Algae Growth due to dampness in the drainage)

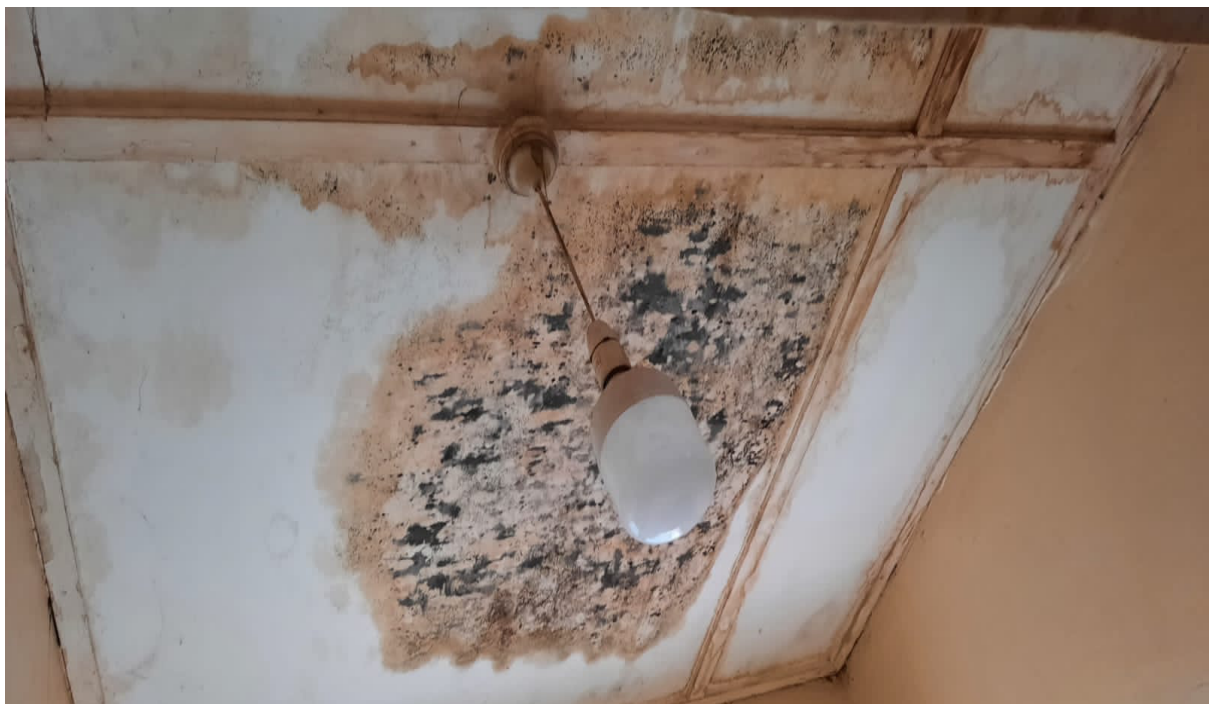
4. The drainage pipes were observed to be free of debris or other unwanted materials that could potentially be blocking the pipes.
5. Extensive decay of the plywood ceiling in many areas of the room. Pic. #4 shows the degree of decay in the ceiling of the building.

3. The extensive decay of the plywood ceiling is the result of the rainwater ingress. The plywood, obviously, apart from having aged is also persistently soaking the leaking water and is thus experiencing a rapid decay.

Pict. #4: Visible Deterioration in the Plywood Ceiling
